Product Update

#P140F

Applies to Flush doors

UNBALANCED DOOR CONSTRUCTION REGARDING AUTOMATIC FLUSHBOLT PREPS

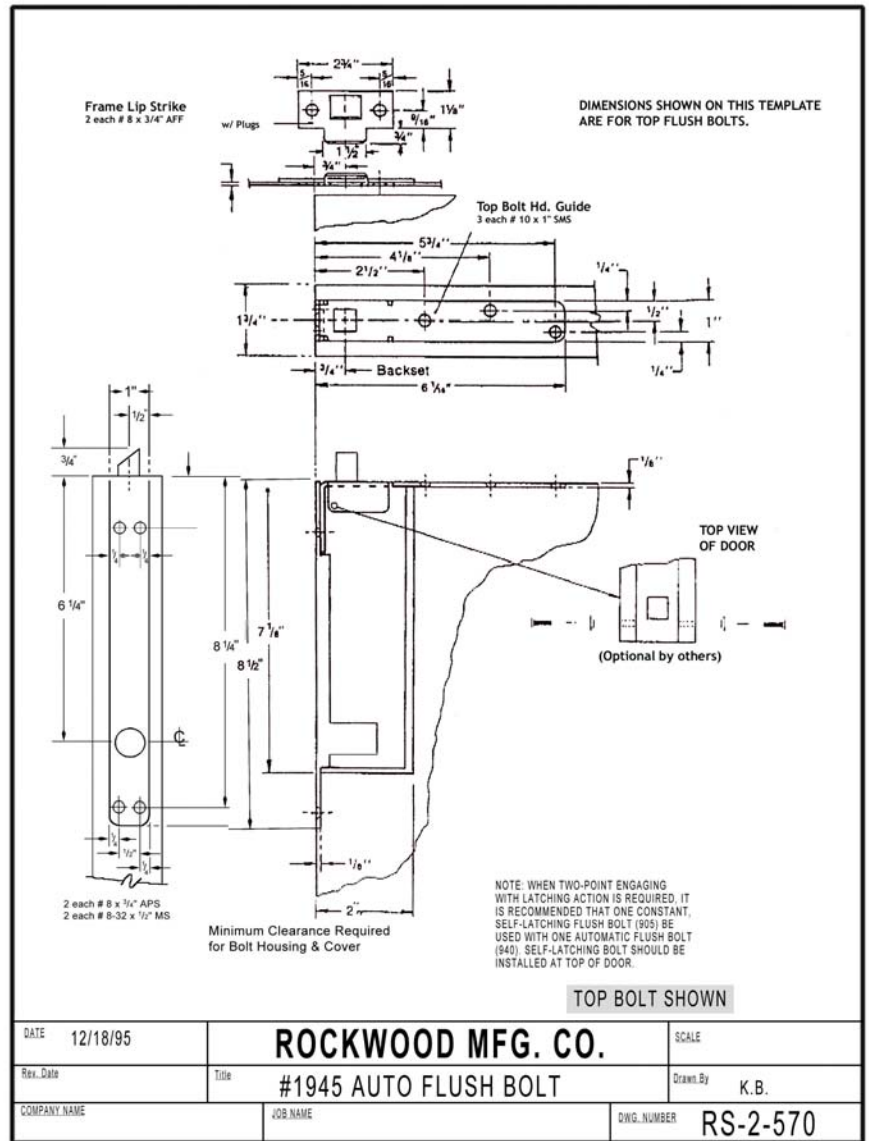
Automatic flush bolt preps in the inactive leaf of a pair of wood doors causes unbalanced construction (veneer/laminate on one face only) at the top and bottom corners of the meeting edge.

The unbalanced construction at these locations may cause the prep to warp, spread or open up. This is not considered a defect in workmanship or material, but rather a natural occurrence with unbalanced construction of a wood product.

1. Drill holes through the face of the door for set screws that will screw into holes on the side of the flush bolt and pull the prep back together (see auto flush bolt template at right).
2. Use a metal channel or astragal on the edge to keep the prep from warping.
3. Use a stainless steel clip (3/4" long by 1-3/4" wide with 1" legs) that can be slipped onto the top or ease of the door, secured in place with adhesive. This will be furnished by VT Industries if requested.

To avoid the possibility of warp or spread, the use of an extension flush bolt should be considered.
