# Product Update

#P140F

## UNBALANCED DOOR CONSTRUCTION REGARDING AUTOMATIC FLUSHBOLT PREPS

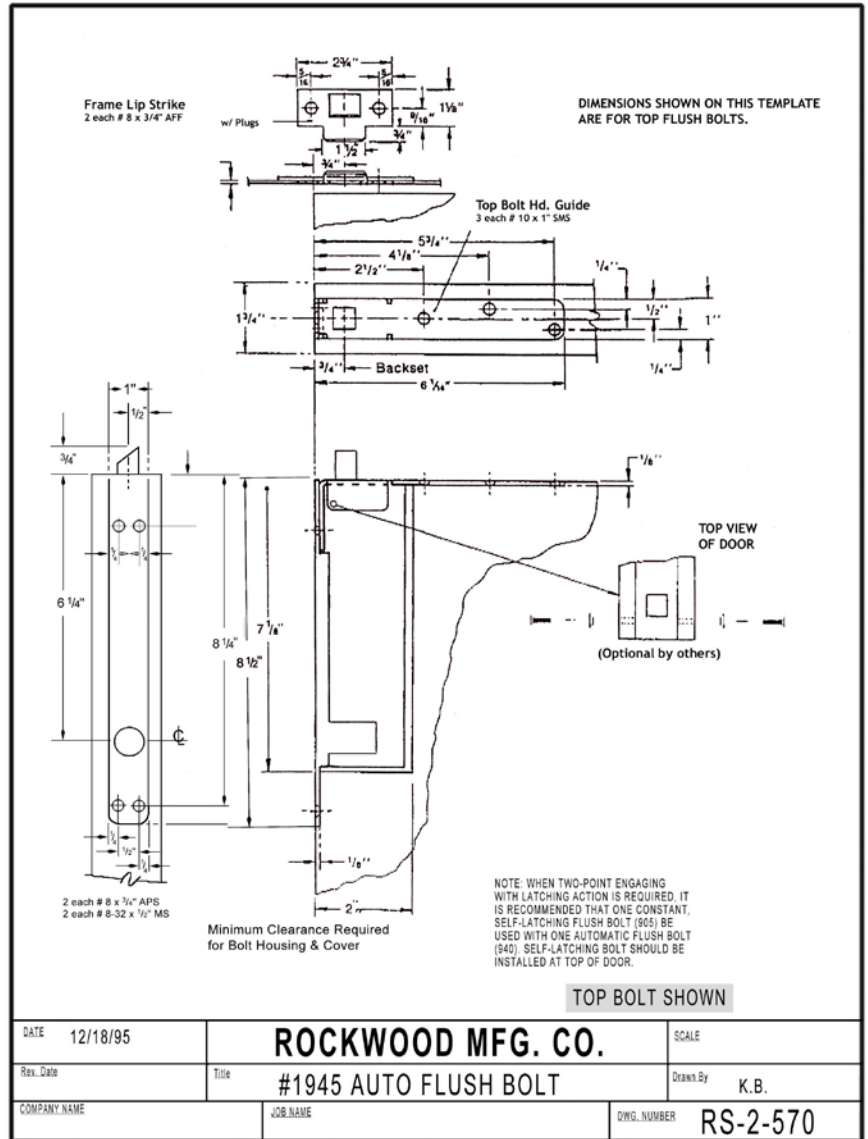
Automatic flush bolt preps in the inactive leaf of a pair of wood doors causes unbalanced construction (veneer/laminate on one face only) at the top and bottom corners of the meeting edge.

The unbalanced construction at these locations may cause the prep to warp, spread or open up. This is not considered a defect in workmanship or material, but rather a natural occurrence with unbalanced construction of a wood product.

1. Drill holes through the face of the door for set screws that will screw into holes on the side of the flush bolt and pull the prep back together (see auto flush bolt template at right).
2. Use a metal channel or astragal on the edge to keep the prep from warping.
3. Use a stainless steel clip (3/4" long by 1-3/4" wide with 1" legs) that can be slipped onto the top or ease of the door, secured in place with adhesive. This will be furnished by VT Industries if requested.

To avoid the possibility of warp or spread, the use of an extension flush bolt should be considered.
